Beam Port Leakage Problem in the BAEC TRIGA Mark-II Research Reactor and the Corrective Measures Implemented

Index Terms— Beam Port (BP), Graphite Plug, Split Type Encirclement Clamp (STEC)

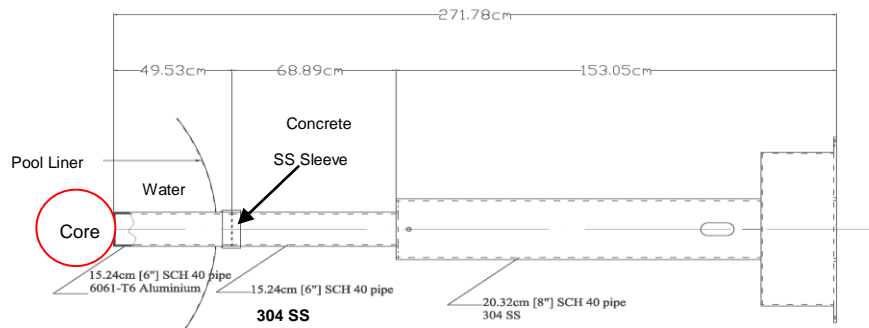
Fig. 2. Details of the Beam Port #1

As shown in Fig. 2, the aluminium part of the RBP-1 which has a length of 48.26cm pierces the reactor pool liner and terminates near the outer surface of aluminium liner of the reactor core. The end of the beam port tube is closed with a 6.125cm thick aluminium disc. The graphite plug occupied about 34.29cm of the aluminium pipe. Therefore about 15.24cm of the aluminium pipe of the beam port from its dead end remained void. The reported leaks developed from corrosion damage mainly took place on the inner bottom surface of the aluminium pipe located at distances from 15.24cm to 35.56cm from the dead end of the RBP-1. Corrosion damage also occurred to some extent on the stainless steel pipe and at the aluminium-steel interface.

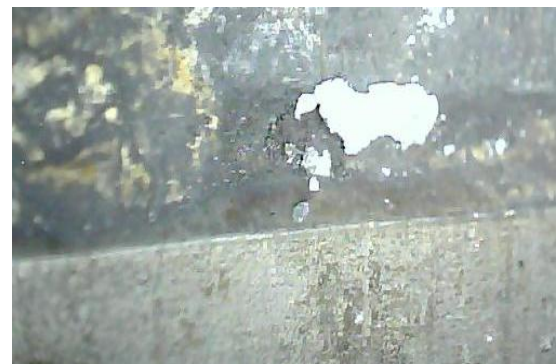
Fig. 3. Inner surface beam port

Upon visual inspection, water condensate was visible inside the polyethylene sheet. This clearly indicated that the corroded part of the graphite plug absorbed moisture from the condensate that had accumulated in the annular space between the plug and the beam port tube. Deposits or scales were found on the outer surface of the lead plug and these deposits consist of species resulting from the corrosion. Photographs obtained from a digital camera inserted into the RBP-1 clearly showed the corrosion damages in the form of metal removal and pits on the inner bottom surface of the aluminium pipe. It also revealed that the damage in the form of pits had initiated at the interface between the stainless steel aluminium. Brown stain marks were observed on the stainless steel surface but no pits or metal removal was found on the stainless steel surface as shown in Fig. 3.
