Component Crack Analysis of high pressure die casting aluminum alloy (Alsi9cu)

Satish kumar Manocha
Designation – Dy. Manager
Department - R&D
Name of industries – Rico auto industries

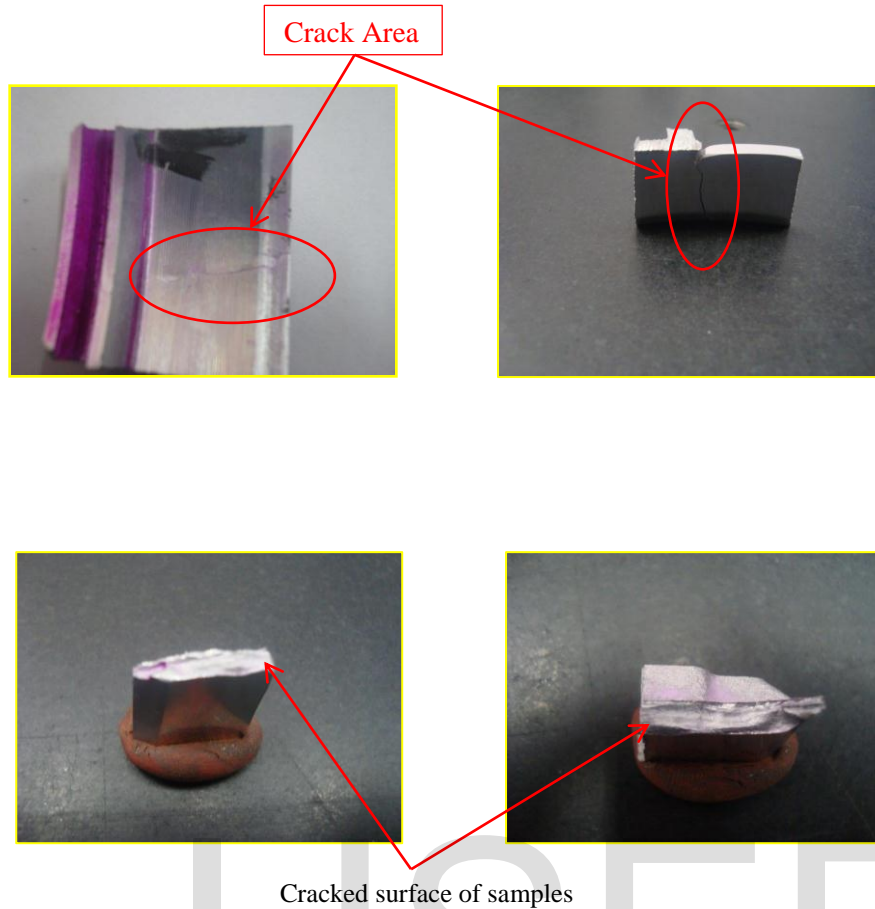
2.PROBLEM - Appeared the cracks in component of Alsi9cu alloy during the assembly process. Due to this casting got rejected at customer end. That condition not suitable for customer is planned and as well as for supplier company. This analysis is required for find out the causes of crack or failure. By this analysis we confirmed that cause of crack is extra load applied or process related.

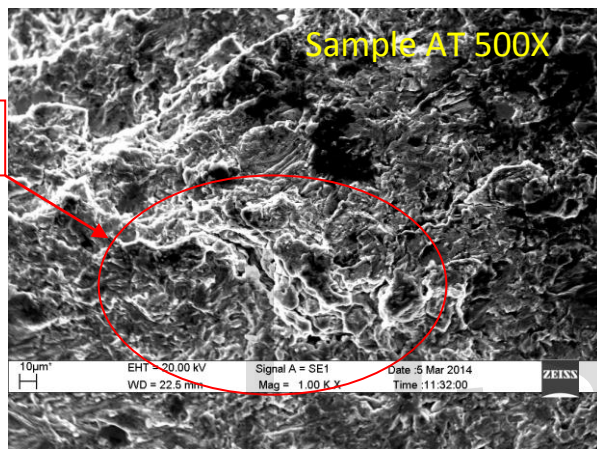
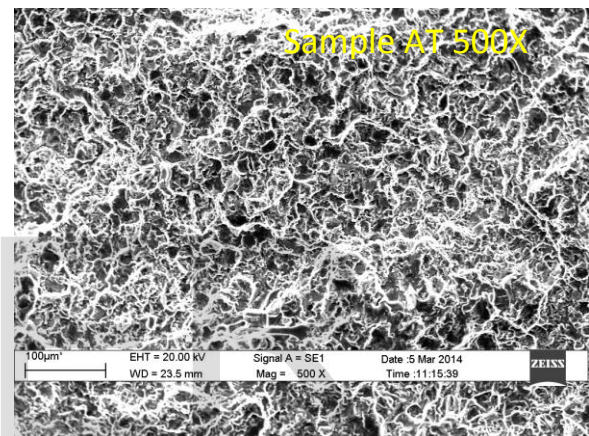
SAMPLE 1

SEM Images of Sample -1 at 500x and 1000X

Faceted fracture surface signifying Brittle pattern. Fracture surface shows dimple and facets pattern. Both Fracture surface shows internal cracks. The reason for failure may be due to internal cracks

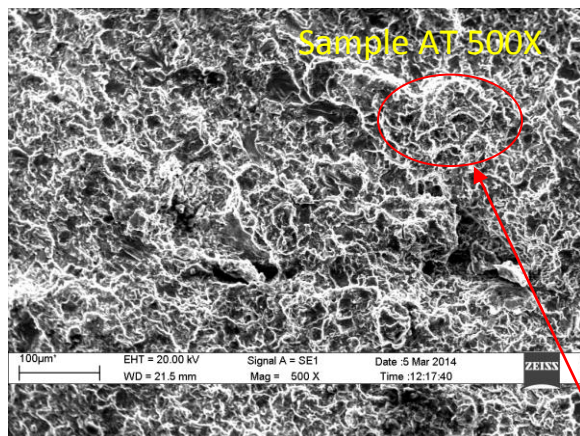
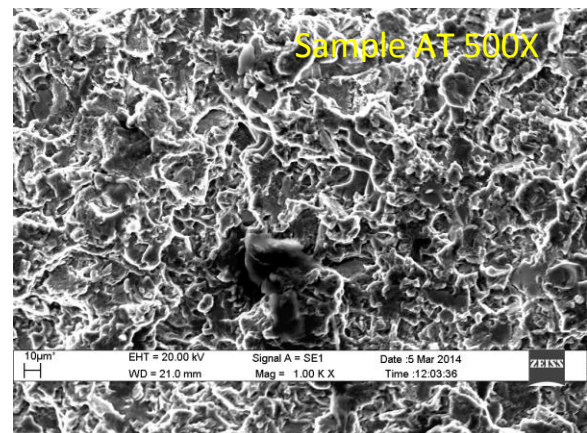
SAMPLE 2

SEM Images of Sample -2 at 500x and 1000X

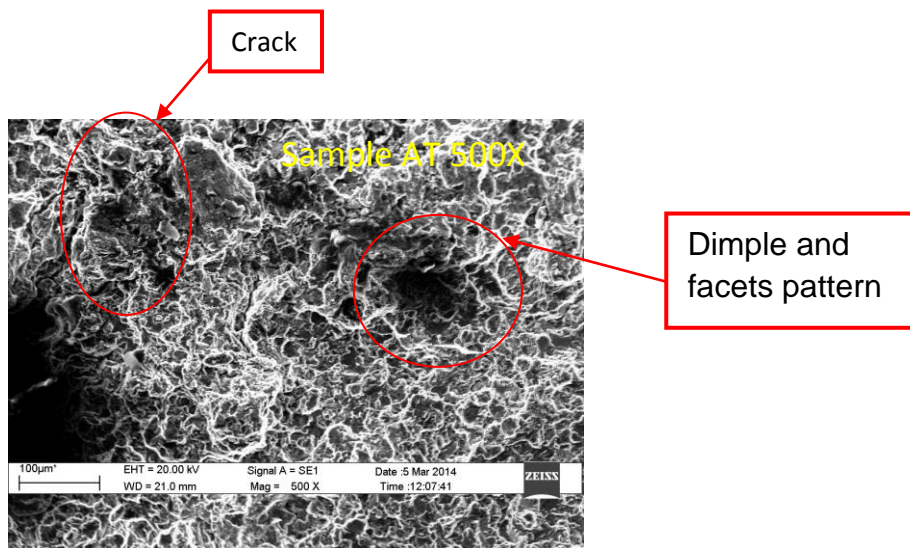
Dimple and facets pattern

SEM Images of Sample -2 at 500X.

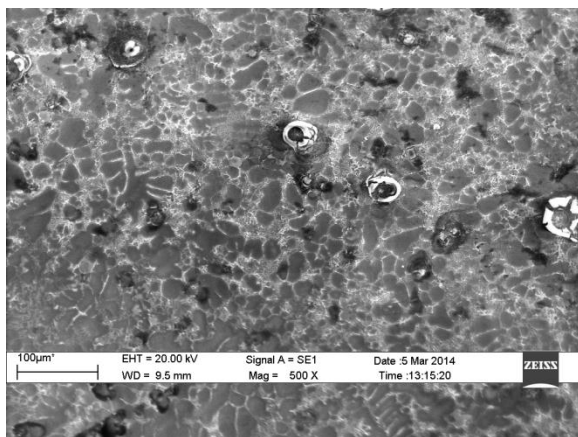
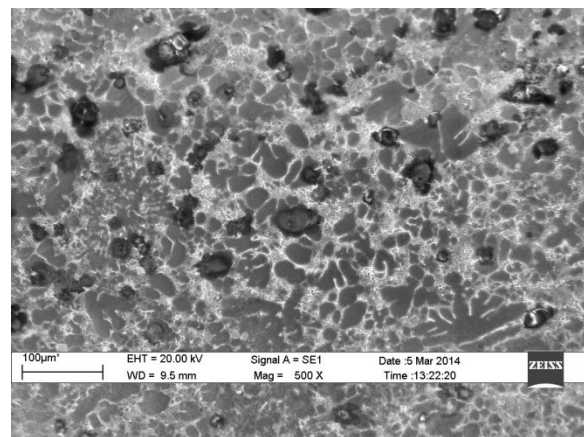
SEM image of sample at 500X

- Non uniform microstructure.
- Coarse distribution of silicon and CuAl₂ in matrix of aluminum.
- Visible surface porosity and oxide inclusions found on sample surface.
- Reference for microstructure: - ASM international handbook.

We required standardization (optimization) of process parameter for entire cycle of manufacturing. By enhancing the Quality and reducing the rejection of casting component.

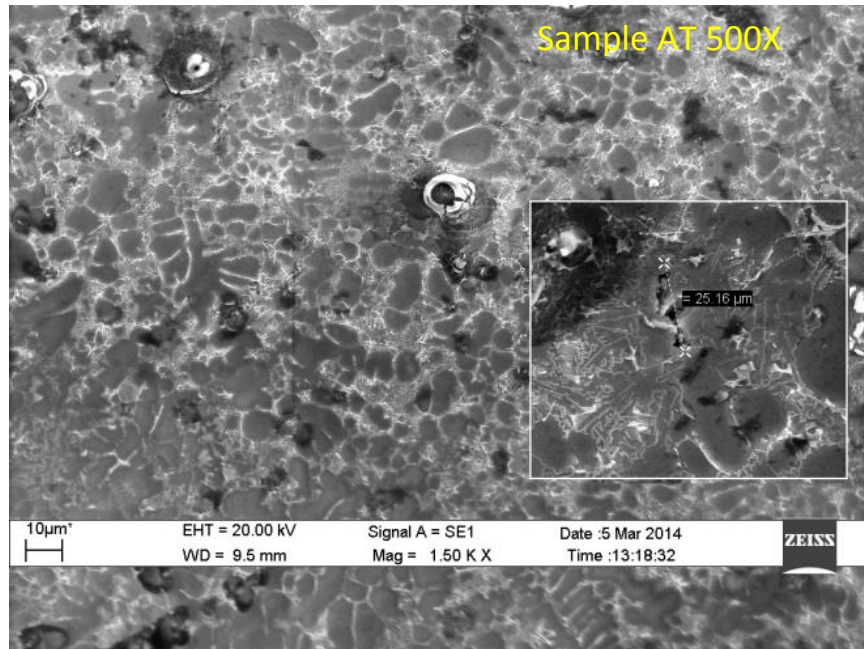
SEM image of micro porosity

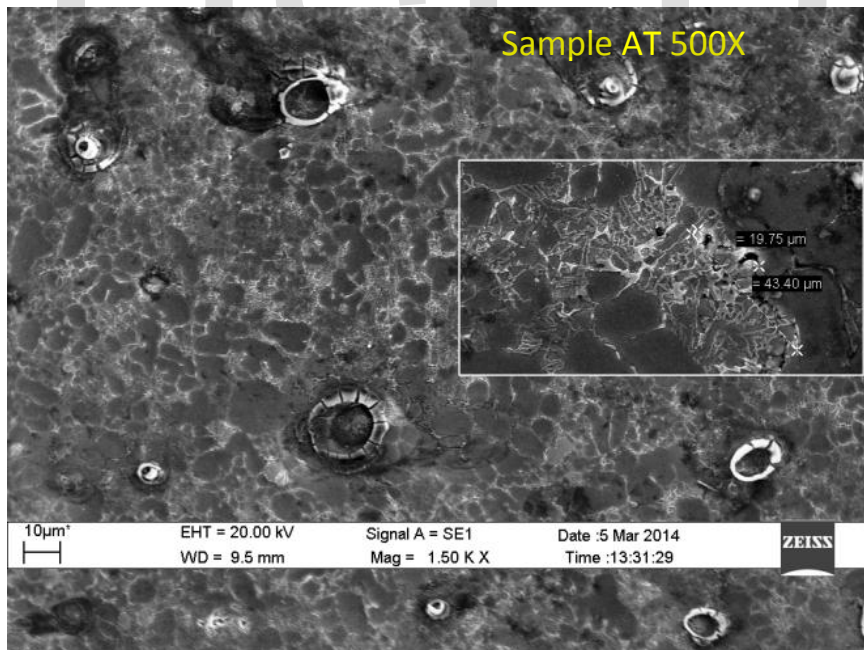
SEM image of micro porosity
