# EXPERIMENTAL STUDY OF SCOUR AT ABUTMENTS OF RIVER KABUL BRIDGES IN PAKISTAN

**Abstract:** The focal problem for river Kabul bridges in Pakistan during maximum flood is scour at bridge pier and abutments causing its collapse and/or isolation from approach road. This will result in bridge failure, human loss, damage to properties and traffic disruption. Keeping in view the problems caused by bridge failure, it is important to check the vulnerability of abutments for failure due to scouring. Therefore, in this study the abutments of two vulnerable bridges i.e. Hajizai Bridge and Pushtoon Garhi Bridge on river Kabul are analyzed for scour depth measurement using small scale modeling in the laboratory. are selected for small scale study. The experiments were carried out for spill-through abutment of Hajizai Bridge and wing-wall abutment of Pushtoon Garhi Bridge. The results showed that the scour occurs in front as well as at both sides of the abutments in both cases. Contours maps are drawn to show the variation of scour depth around the abutments in both cases.

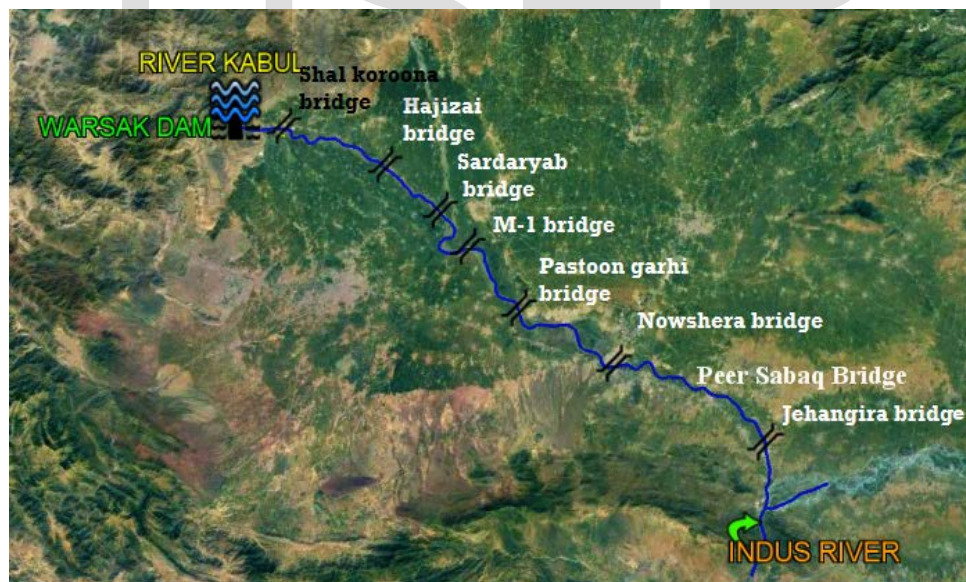
*Figure 01 Bridges on river Kabul in Khyber Pakhtunkhwa Pakistan*

The river Kabul is historical significance for Pakistan its total length is about 700km out of which 140km in Pakistan. River Kabul is started from Hindu Kush Mountains and finally end into Indus River near Attock Pakistan. The major tributaries in Afghanistan are Logar, Panjshir, Kunar and Alingar while in Pakistan river Swat, Budni nullah, river Jindi and Bara stream. All constructed bridges on river Kabul are mostly pre-cast girders bridges and two are steel truss bridges which connect various districts of Khyber Pakhtunkhwa province of Pakistan as shown in figure 01 below.

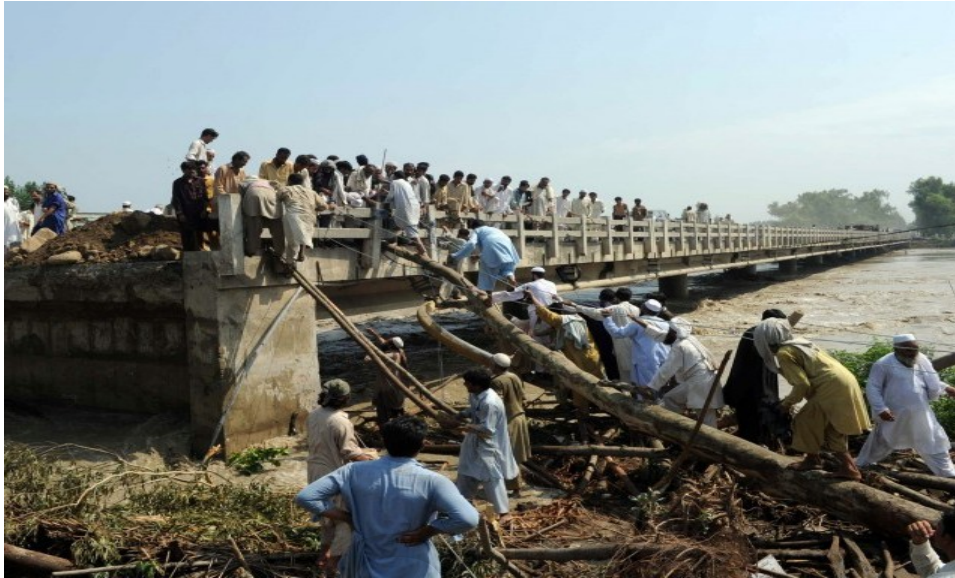
*Figure 02: Extreme scour at bridge abutment of Sardaryab Bridge on river Kabul during flood, 2010*

Scour at the above four locations /regions occurred at different rates and can varies up to extreme depth, in accordance with flow-field and soil conditions and finally at each location the scour create slope instability of adjacent embankment as shown in Figure 2 below.

The figure 02 shows the importance of abutment scour study of river Kabul bridges. The isolation of bridges abutment from approach roads were observed during flood of 2010 in Pakistan. In this research study, experimental study was carried out to measure the abutment scour depth for two bridges on Kabul River. The aim was to find the scour depth as well as its location.

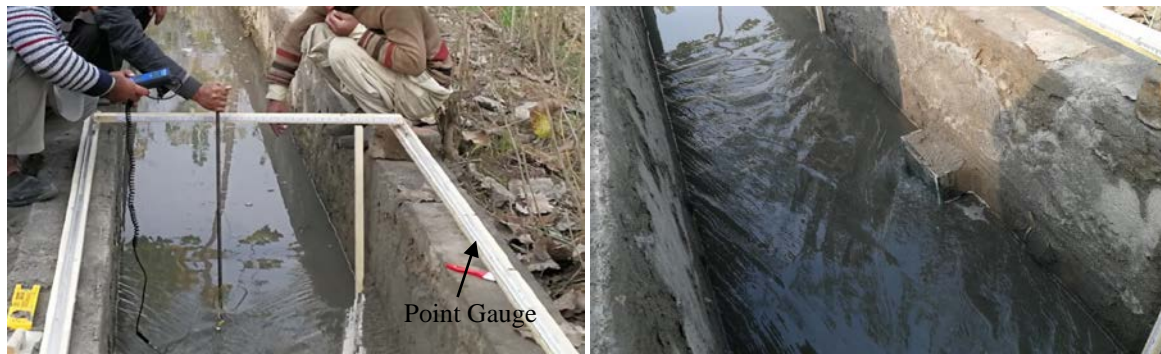
**Figure 09: Model Channel, Discharge Confirmation, Abutment Set-out and flow of water in Model Channel**

A rectangular cross section irrigation channel of size 90cm width and 90cm depth near tributary of river Kabul was chosen for both experiments so that to use river Kabul water flow. A straight portion of channel for test section was selected at adequate distance (40m) from diversion gate to obtained uniform flow of water. For Hajizai Bridge experiment the prepared reduce size material (sandy gravel) while for Pushtoon Garhi Bridge experiment the collected

river bed material from bridge site (fine sand) was recess in 30cm thickness at test section plus ample length at upstream and downstream and leveled with wooden screed in full width of channel respectively.

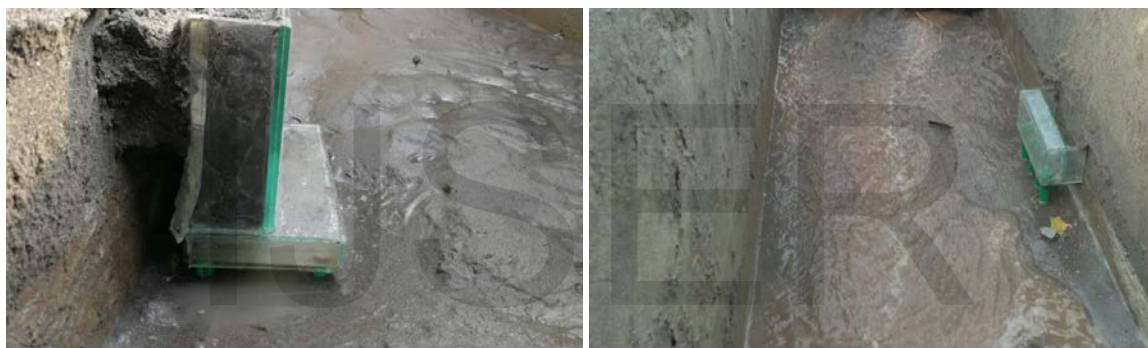
**Figure 10: Showing Scour Holes at Wing-wall Abutment of Pushtoon Garhi and at Spill-through Abutment of Haji Bridge**

The glass model of bridge abutment was installed at one side of the channel at test section. Prior the flow levels of bed material were taken with help of point gauge on grid with mesh 12.5cm x 20cm at test section and noted. The water was released slowly from inlet of proposed channel up to confirmed 8.0 Cusec discharge (8.0 Cusec equal to August, 2010 flood for Hajizai and July, 2013 flood for Pushtoon Garhi Bridge). The flow was run for 90 minutes to ensure that scour had reached the equilibrium depth. After 90 minutes flow, the water was stopped from diversion point and all water was drained slowly without disturbing the scour topography. The bed topography was measured with point gauge on same grid with mesh 12.50cm x 20cm at test section and noted.

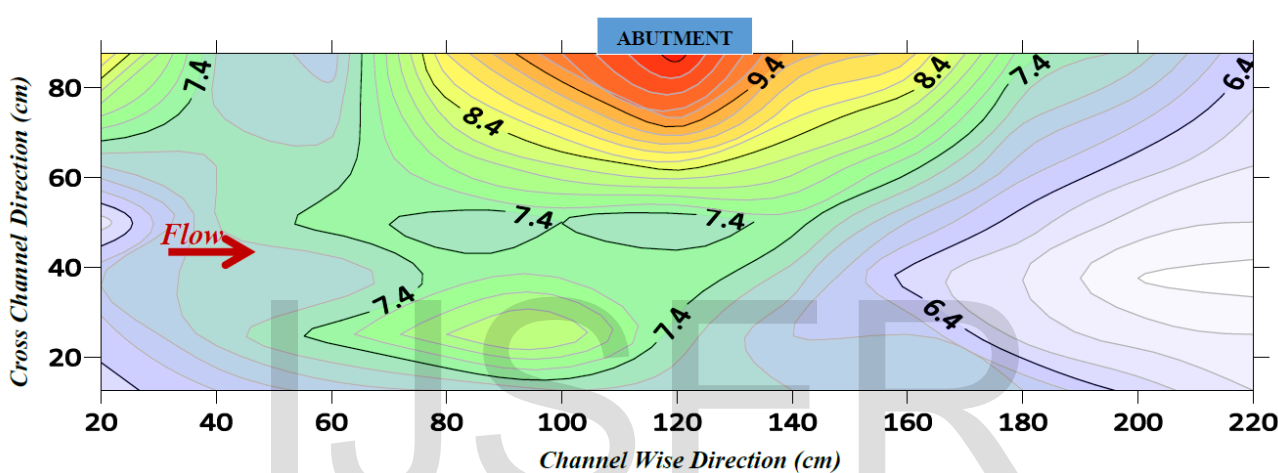
Figure 11: Scour Contour Map for Hajizai Bridge Spill-through Abutment

Scour contour map was plotted (figure 11) in surfer software showing the scour at front and around the abutment.

The experiment was revealed that all piles of spill-through abutment exposed up to maximum limit which need some scour protection countermeasures at front of abutment as well as at upstream and downstream of spill-through abutment. Therefore, it was concluded that spill-through abutment should be constructed at sufficient distance behind from flood plan plus scour countermeasures must also provide at front and around the abutment.

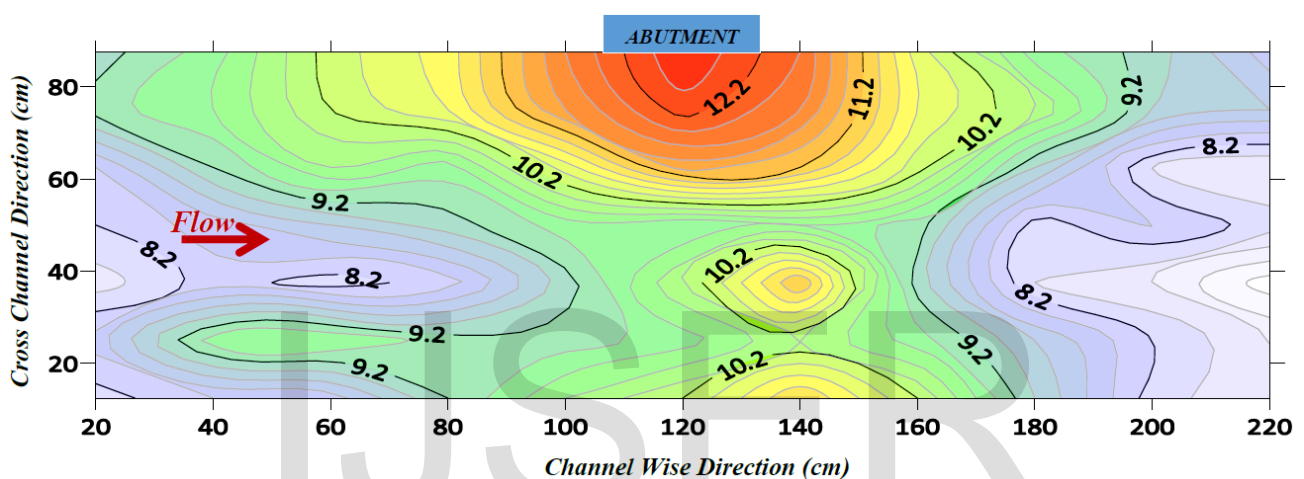
Figure 12: Scour Contour Map for Pushtoon Garhi Bridge Wing-wall Abutment

Scour contour map was plotted (figure 12) in surfer software showing the scour around the pile cap of abutment.

The experiment was revealed that the piles beneath the pile cap exposed up to some extent which can be avoided by increasing the depth of pile cap under natural surface level of river. While for upstream and downstream protection some countermeasures are required.

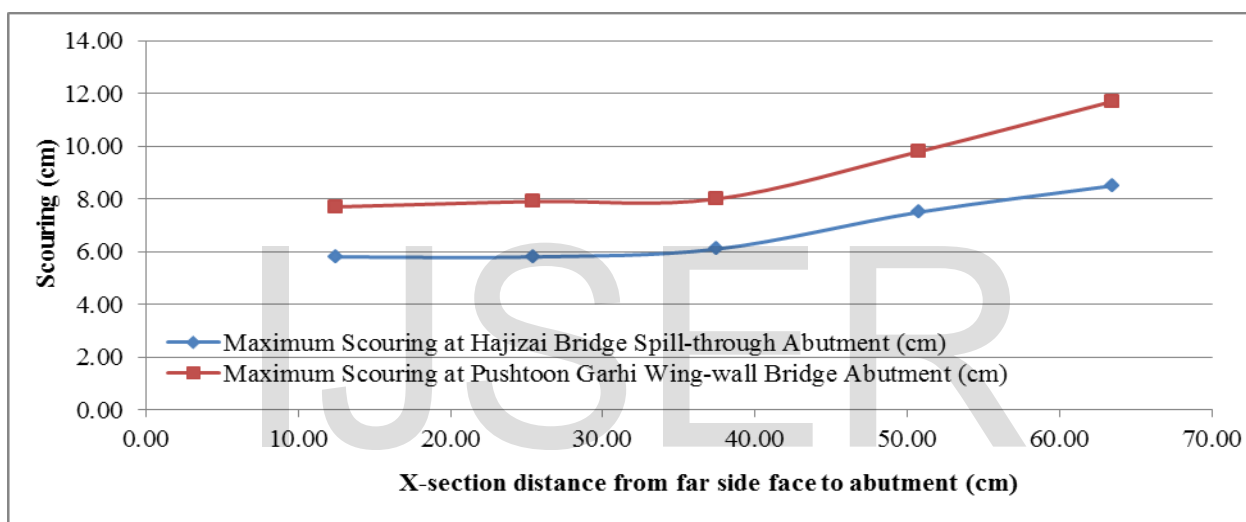
Figure 14. Comparison of Scouring at Spill-through Abutment of Hajizai Bridge and Wing-wall Abutment of Pushtoon Garhi Bridge Across the Channel

The comparison of scouring at both types of abutment carried out through graphs along length of channel and width of channel. Almost similar results were obtained maximum scour observed near both abutments as compared to scour at far side of channel. Lesser scour depth was observed in gravel river bed material as compared to fine sand river material.
